BASTIÓN DE SAN DIEGO

INTRAMUROS ADMINISTRATION
MINISTRY OF HUMAN SETTLEMENTS

The conservation of Bastión de San Diego began on March 17, 1979. This initial effort to clear the structure of vegetation and waste led to the discovery of interesting architectural features, many of them previously unrecorded and photographed.

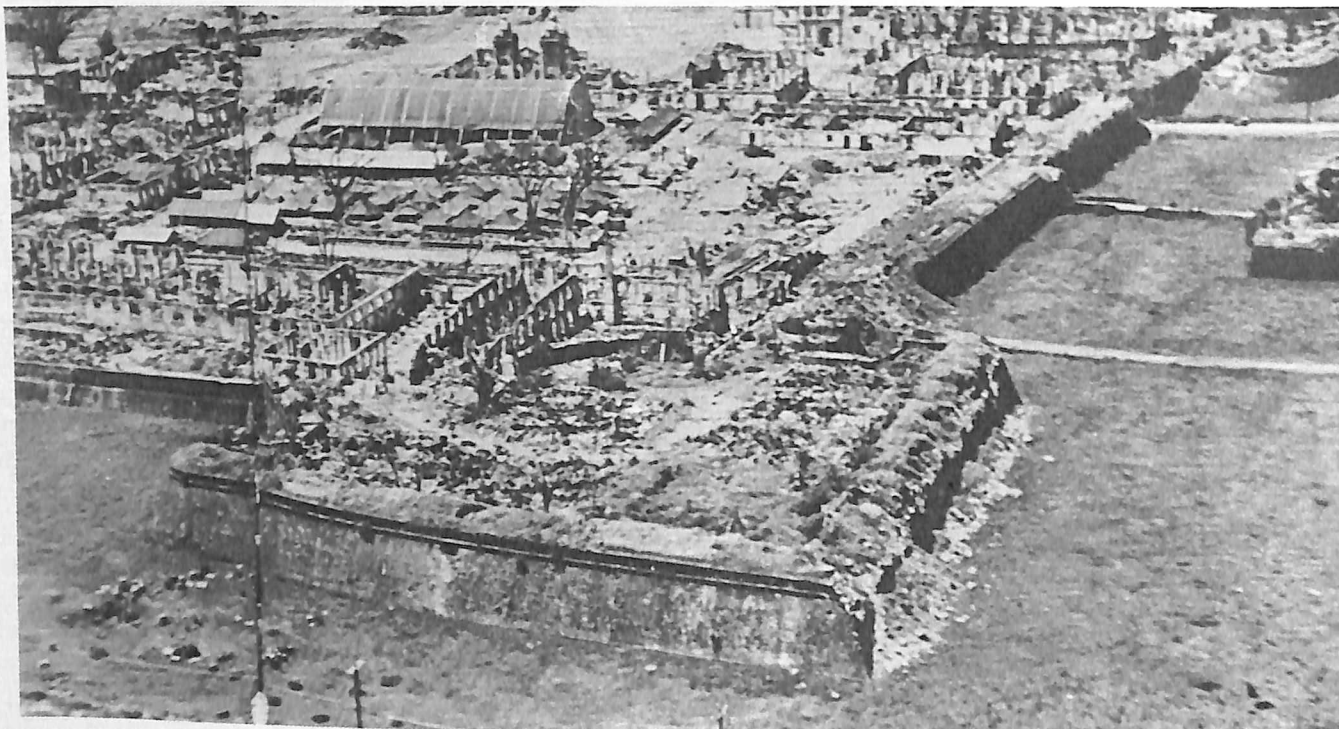
Figure 15. What remained of Bastión de San Diego and the surrounding establishments after the shelling of Manila in 1945. As in the British attack, the southeastern face of the bulwark bore the brunt of the bombardment. From among the ruins, one fails to identify the north garita.

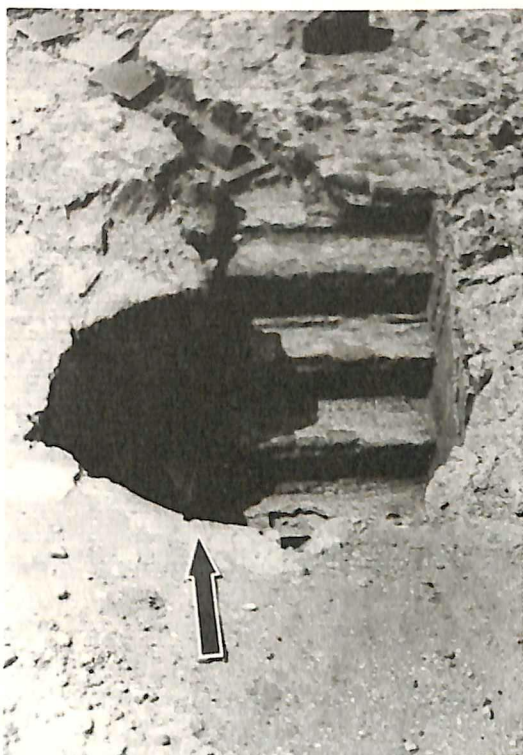
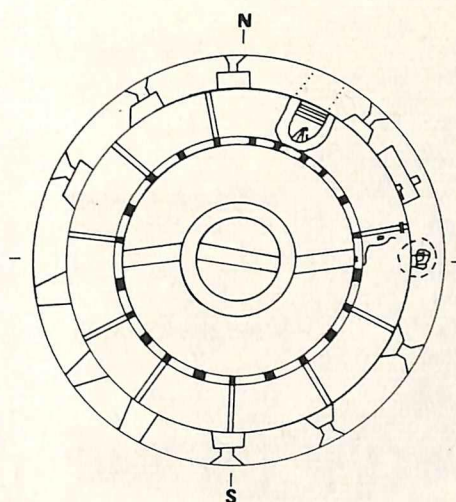
Figure 16. Top view of the stairwell built within the wall of the third circular structure.

Figure 18. A view of the stairwell. Acroposts support some of the loose stones of the structure. Numbers one and two indicate missing stone members of the original winding staircase.

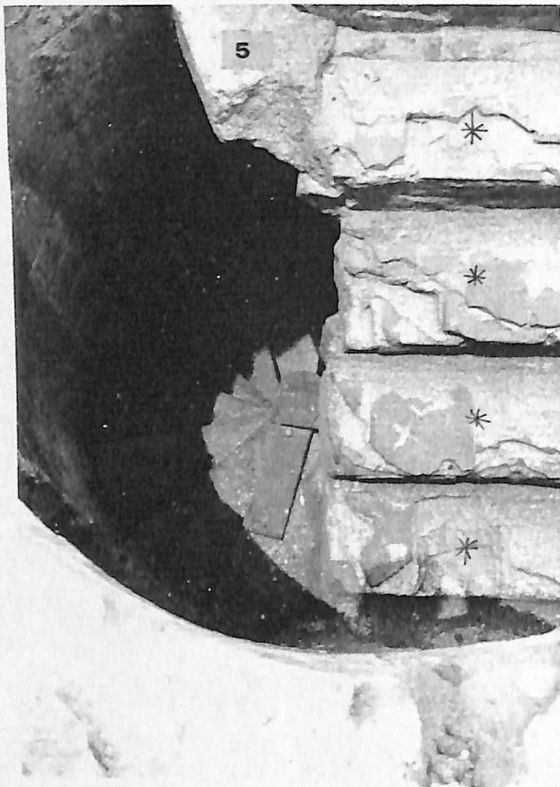
Figure 19. This straight stair was added to the structure at a much later period (see reconstructed documentation of the spiral staircase early and later period, below). It led to a ledge and a low opening that leads to the staircase by the manhole.

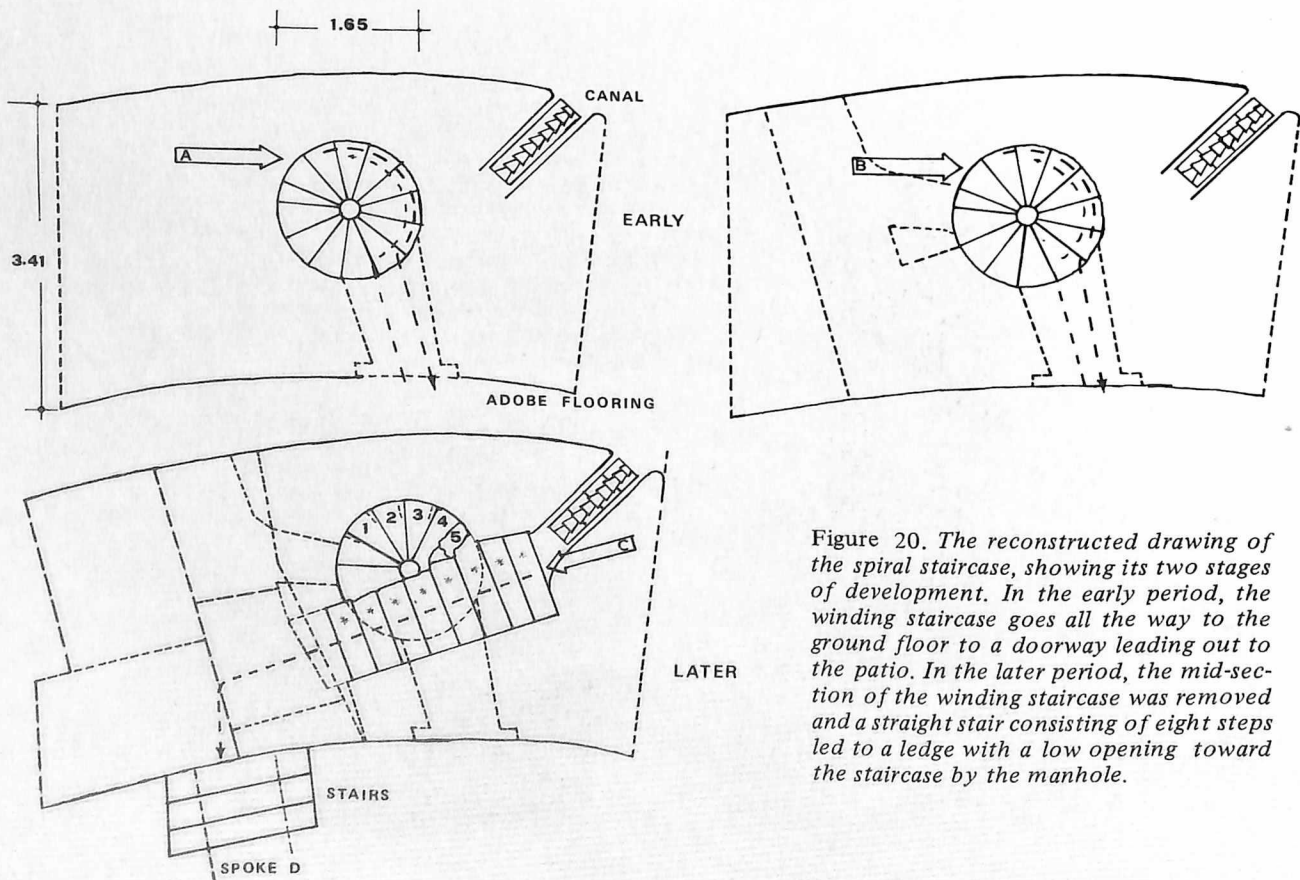
Figure 20. The reconstructed drawing of the spiral staircase, showing its two stages of development. In the early period, the winding staircase goes all the way to the ground floor to a doorway leading out to the patio. In the later period, the mid-section of the winding staircase was removed and a straight stair consisting of eight steps led to a ledge with a low opening toward the staircase by the manhole.

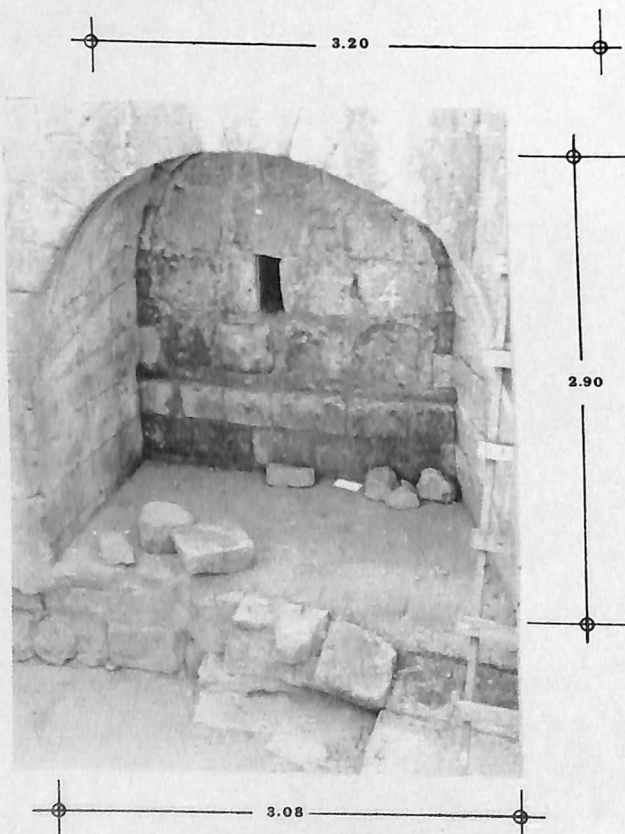
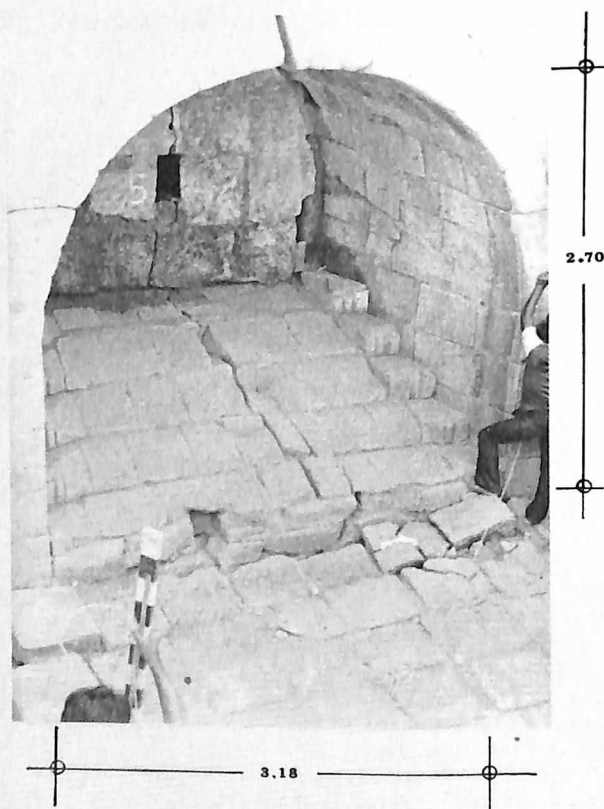
Figures 25, 26, 27. Casemates Nos. 4, 5 and 6, all located on the southwest quadrant, are simply arched chambers. All have the narrow apertures mentioned in Román's description of the old tower. They have taller arches but narrower width.

Casemate No. 5 has a gradually sloping floor, which could have been used for pushing the cannon up the ramp. It appears to have all the features of the older construction, even the paving outside its chamber.

Casemate No. 6 appears in a "disturbed condition." Its opening has been partly sealed by adobe blocks from flooring till midway of the arch. Soil fills its inner cavity, in an attempt, perhaps, to raise the flooring. On the other hand, the flooring of casemate No. 4 follows the style or manner of the newer casemates.

It is to be observed that chambers four, five and six (Figures 25-27), located within the southwest quadrant, appear to be of cruder construction, whereas the remaining chambers look better finished and have wider openings oriented outwards (Figures 21, 23-24, 28-32). Again, the aforementioned chambers have narrow apertures that recall Román's complaint: mere loopholes through which the artillery protruded. Beyond noting these differences and impressions, one has also to admit that there are no further corroborative data which could establish the age of the chambers.

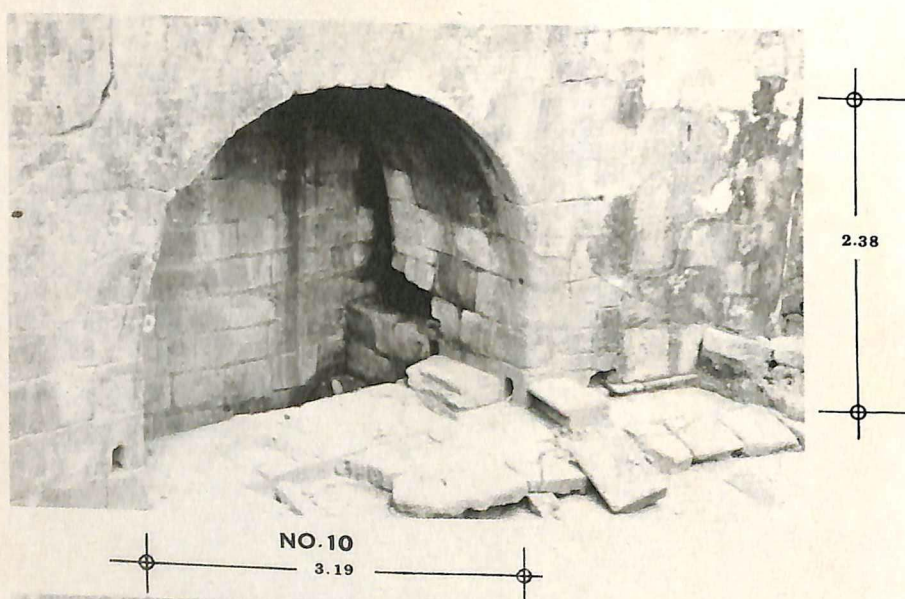
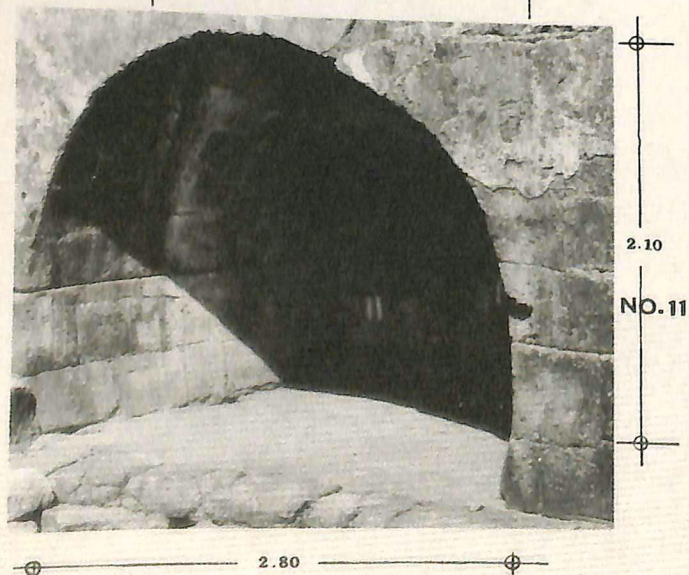
Figure 31. Casemate No. 10, which appears to belong to the same period as 4, 5 and 6, has a split-level flooring. The outer chamber is on the same level as the ground floor but its inner chamber has a deep trough several meters deep. Its arch is also semi-detached from the wall, revealing a tiny archway leading upward toward the spiral staircase. The entrance of the outer chamber has deep grooves which might have held some kind of door.

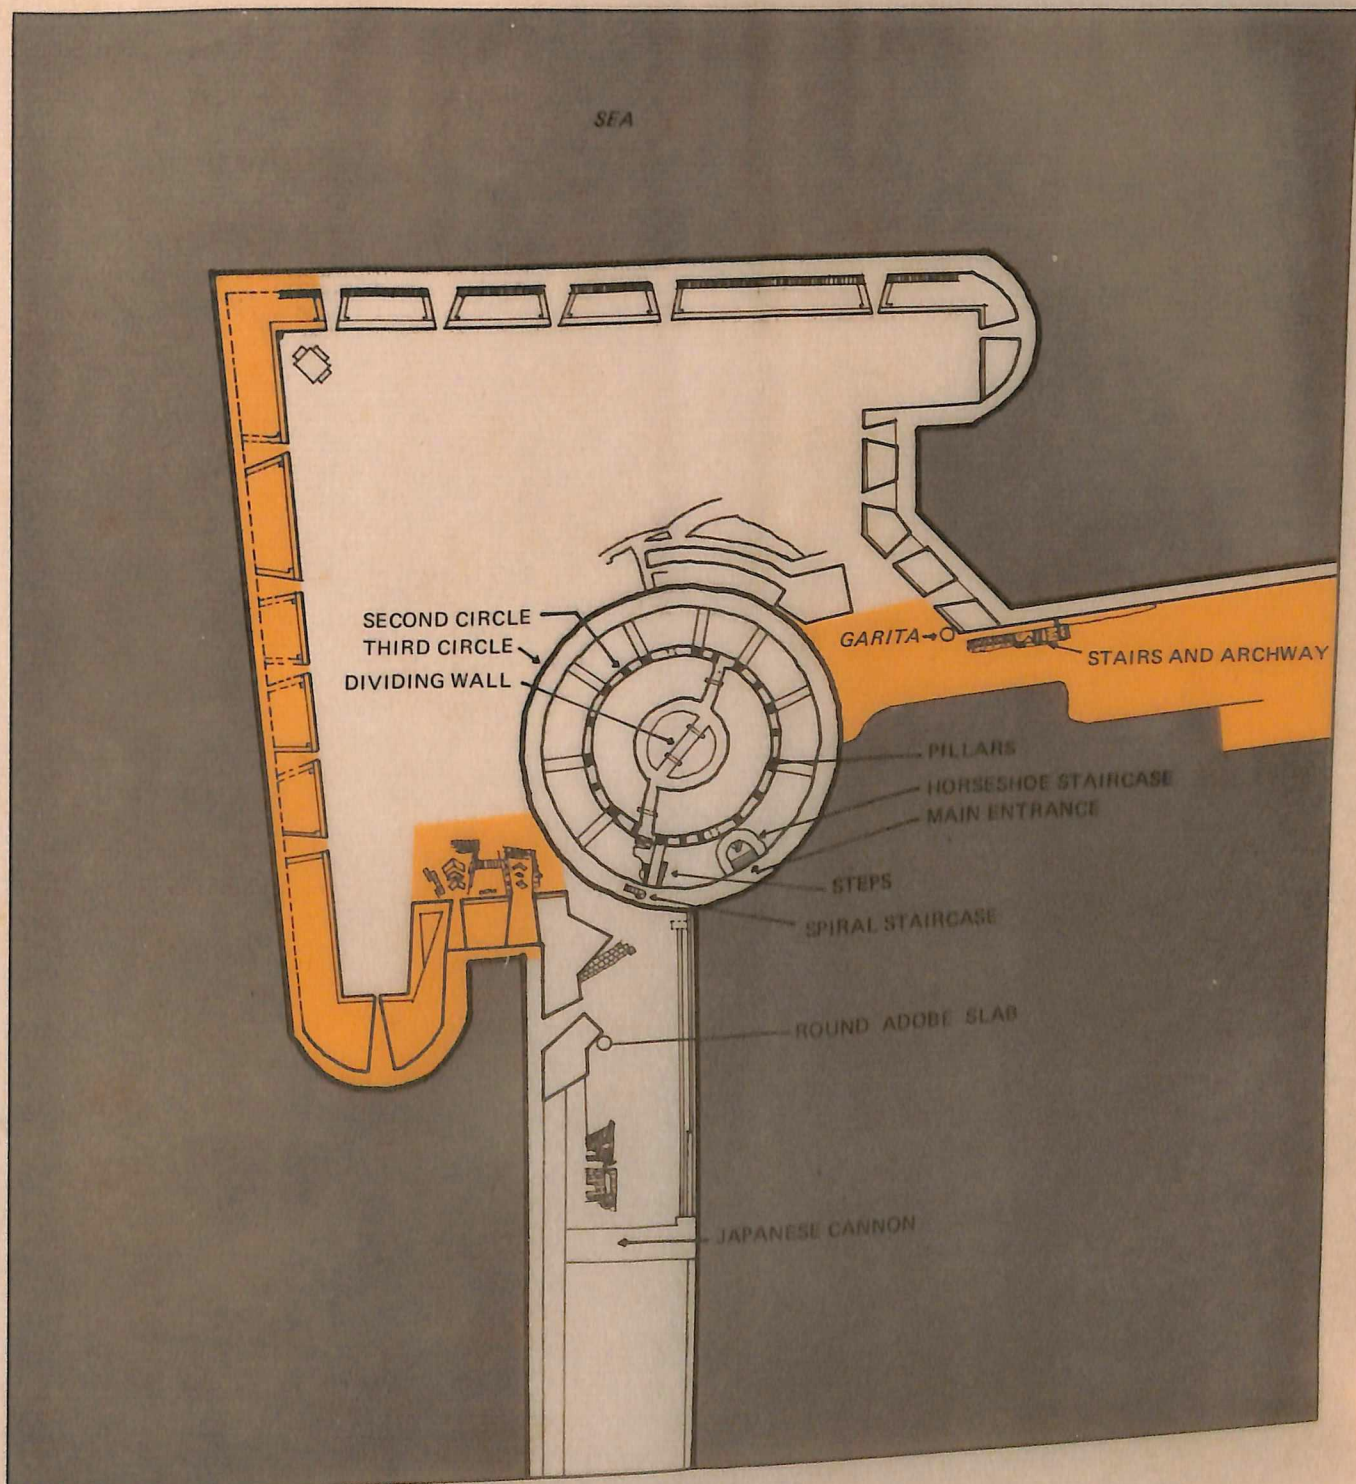
Figure 33. Bastión de San Diego shown at the end of the excavation in 1982. Besides the parapet and the lone garita on the north flank, various other structures appeared as the soil fill was removed: gun emplacements on the east orillion, stairs facing the tip of the bulwark and the three circular structures. Below the terreplein appeared the horseshoe staircase, the spiral staircase, the three sets of stairs sandwiched between the ground of the third and second circle, east quadrant; the subterranean courtyard to the west and the archway and stairs by the curtain wall on the north corner.

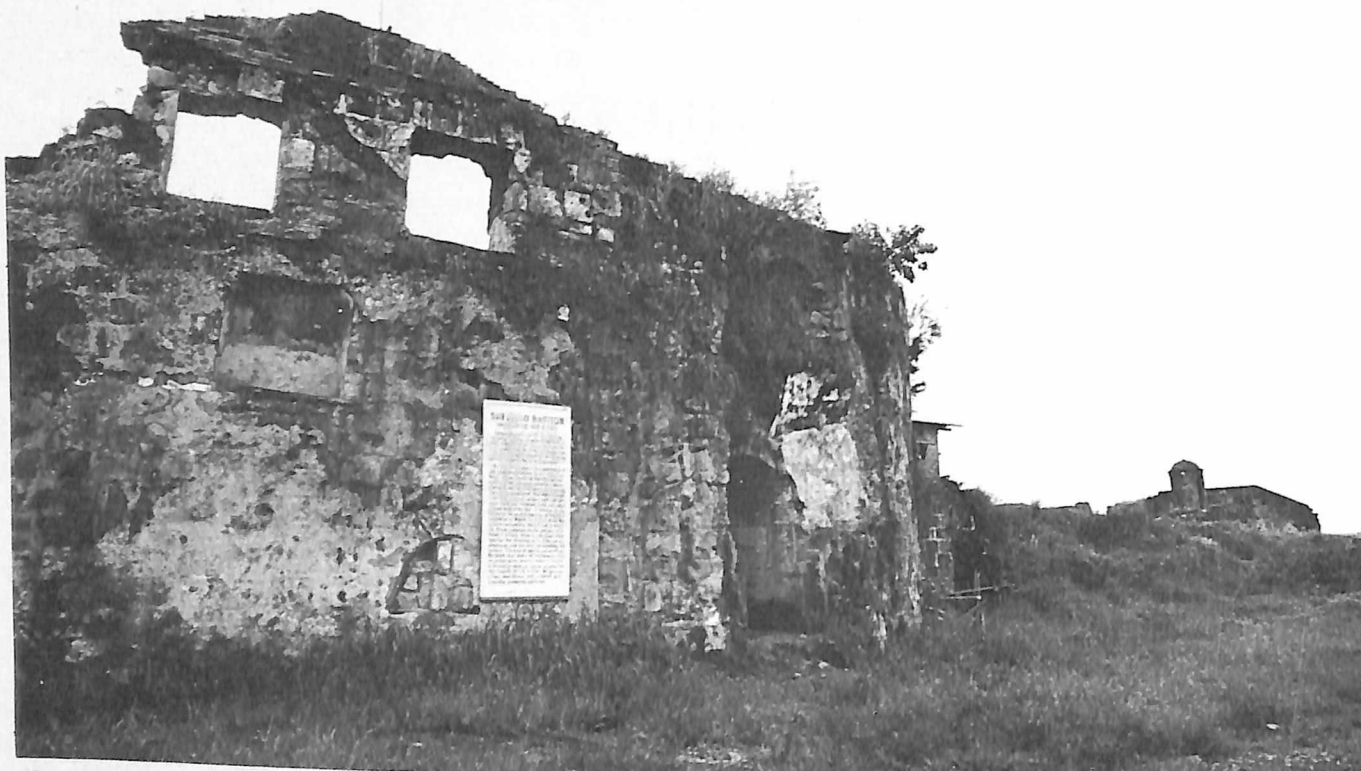
Figure 42. The forlorn ruins of the Bastión de San Diego as it looked in September 1979. Its one surviving garita keeps a lonely watch on the north flank.

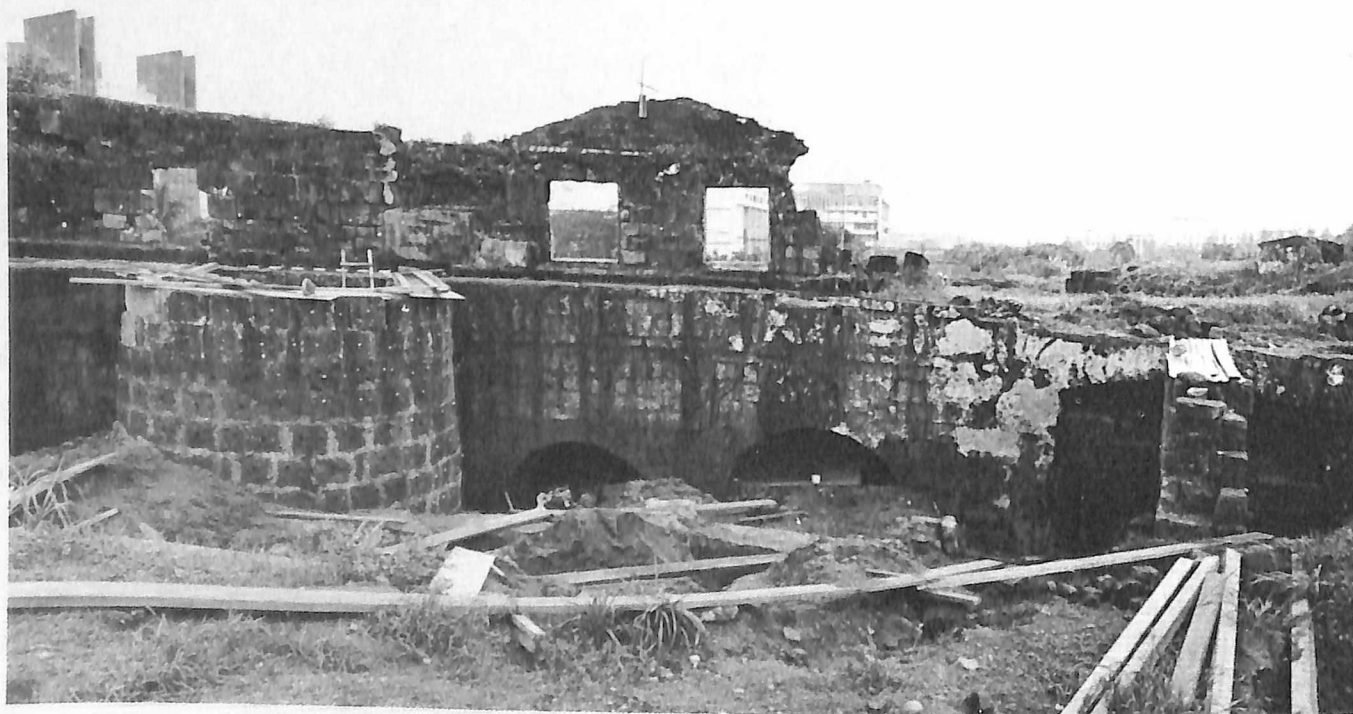
Figure 43. The interior of the Bastión de San Diego presented a bleak view during the early stages of excavation. The Executive House is on the far right-hand corner of the picture, and to the left the concrete buttresses of the Pamantasan ng Lungsod ng Maynila cut through the Intramuros skyline to hold the earthquake-damaged building.

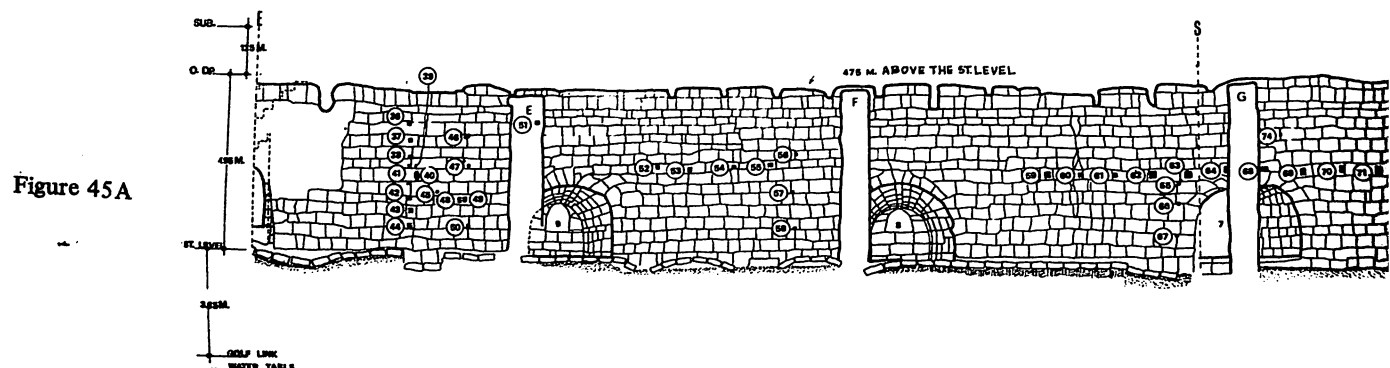
Figure 45A

Figure 45, A and B. The documentation of the interior portion of the third circular structure showing the condition of the walls and casemates and the position of the buried chambers below the street level.

The archaeological excavation shows that the flooring outside the casemate is 3.45 meters above the water table. It is estimated that the underground arches that provide structural support to the tower would be at least 1.75 meters high, the average size of the casemates (Figure 45B). An adobe footing of at least another meter would be necessary to anchor its structure, adding up to almost the exact height of the lowered tower! Dasmariñas had shown himself an astute planner and builder and it is likely that it was in consideration of the foundation—how much weight it could have supported—which influenced his decision to limit the tower's height to 4.37 meters. The lessened height allowed the structure to settle evenly.

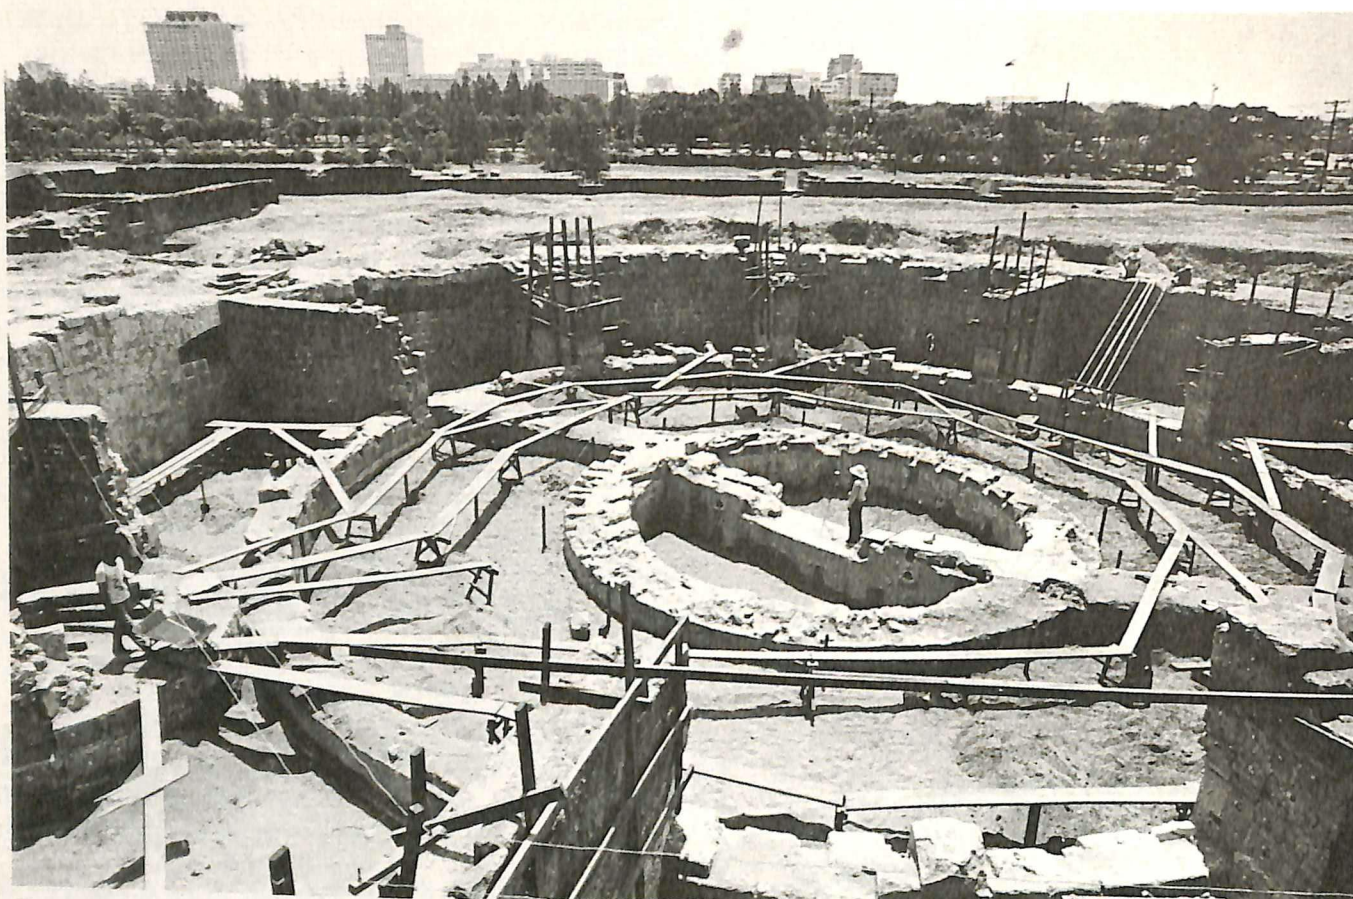
Figure 46. The two cylindrical structures in the early phase of the excavation. Some five meters deep of earthfill have already been removed.

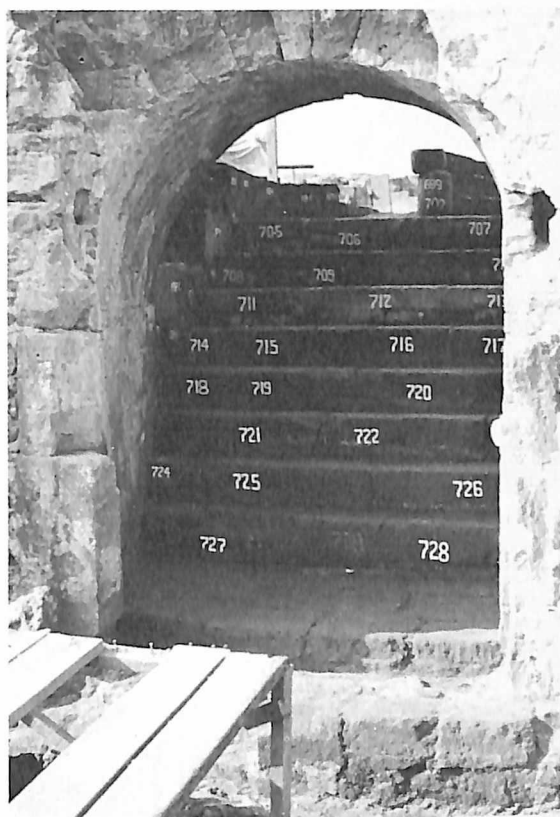
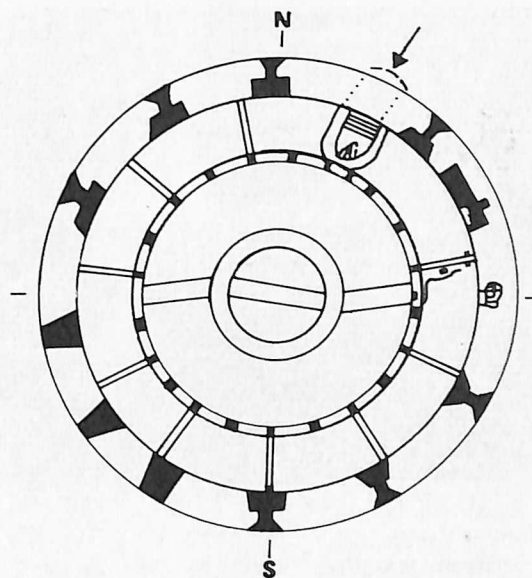
Figure 47. Marks on the door frame of the Bastión de San Diego indicate that one time it may have been barred with a swing-out metal or wooden door.

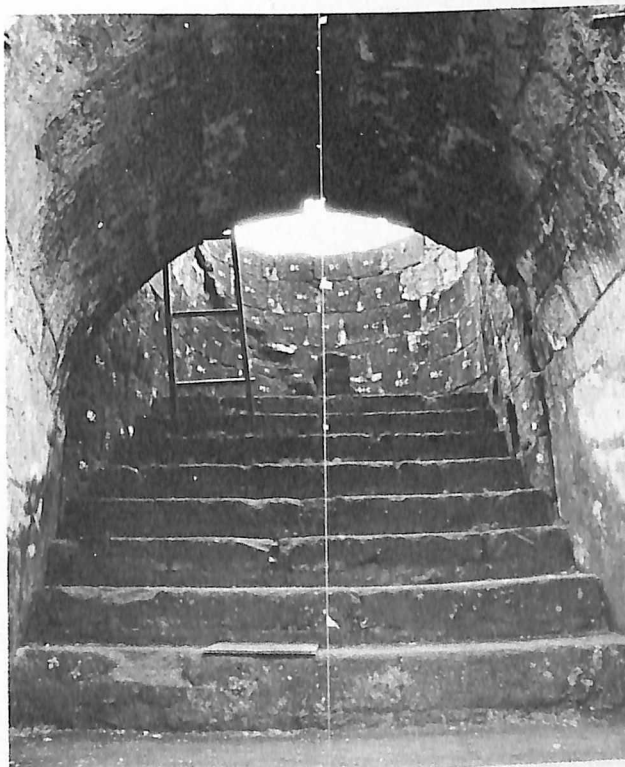
Figure 48. The main entrance of the Bastión de San Diego. On the wall of the stairwell, vestiges of the dismantled steps are visible on the stones.

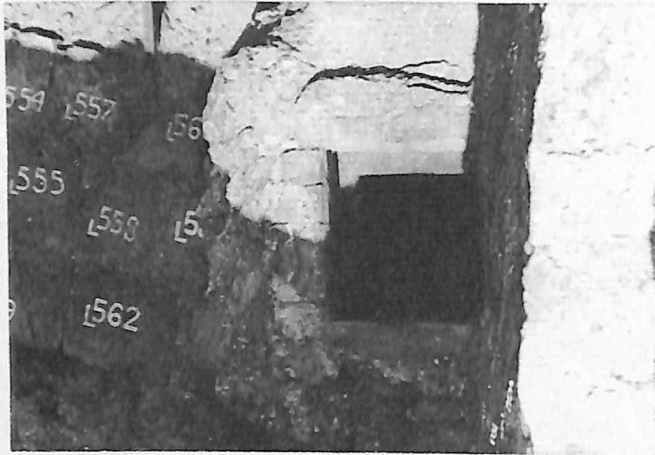
The manhole in my opinion, is integral to the cistern (Figure 57). Its method of construction closely approximates that of the cistern; it is well laid and plastered with the same type of terra-cotta finish. Had it been any ordinary drainage outlet, then there would not have been any need to plaster its interior wall. The mouth of the manhole is also slightly tilted to one side and not flatly laid out on the ground. It seems as though they were trying to prevent any build-up of water in its vicinity. It is a suspended construction, or so it seems, anchored only by the packed sand to the wall of "spoke D."

Figure 57. Aperture of the manhole or tunnel located on the northeast portion of the circular structure. It has a vertical entrance, three meters deep, sealed off by a large stone slab. The tunnel runs northeast for only two meters, stopping where a cave-in has occurred. It is assumed that this opening had been pried loose in the last decade because of the presence of contemporary materials like rubber slippers, plastic comb, tin cans and Garand clip.

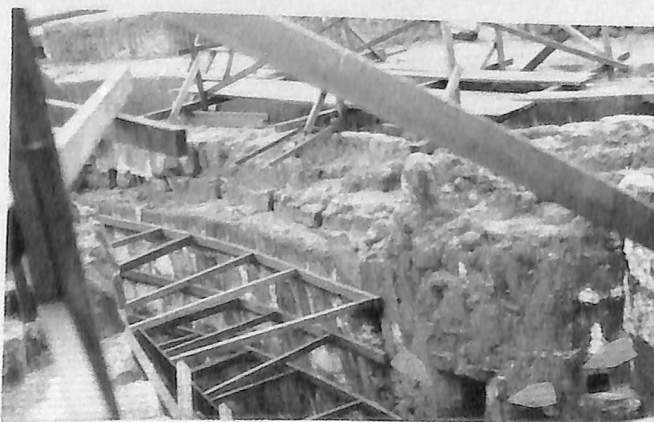
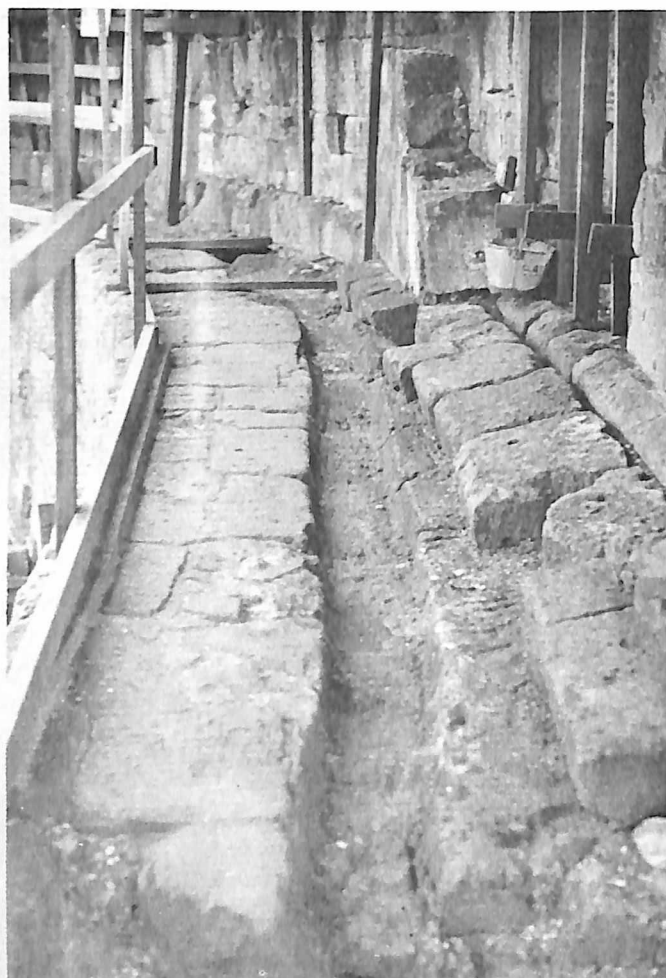
Figure 78. Waterway found on top of the third circle. The canal may have originally been covered with adobe. It may have been built to prevent build-up of water on the top of the structure.

Figure 77. A system of drainage found within the third circle's top wall. Water drains out to the terreplein. The system may have belonged to the old tower.

Surrounding the third circular structure on the terreplein is a canal-like groove. The portion on the northeast section is still fairly complete, and here the stone arrangement on the outer edge is tipped toward the groove. Indications also show that the canal was previously covered with adobe stones (Figure 78). Simple tests were conducted to determine the passage of water into the structure. Large quantities of water were poured into the canal which invariably traveled to the duct on the dividing wall. Gurgling sounds were heard around the "manhole." It was then supposed that water passing through the duct on the dividing wall inevitably ended in the "manhole." But it was not evident how the water reached there. That water was kept clean by a cover of adobe stones seems to represent an intention to conserve this water as well. Of course, one obvious reason for lining the top of the canal was to make it a more convenient walkway.

On the interior wall of the third circle on the west quadrant, there is a series of grooves that leads to a duct, which we assume to be a drainage outlet (Figure 77). We could only listen to the sound of water trickling down the structure. How its system operates is another matter that for now must remain a mystery. For to learn of its function and its value, one has to dismantle it. This would require such careful documentation and study and the supervision of an archaeologist in removing and restoring the stones. Only in this manner could one guarantee its faithful restoration, and unless this was ensured, it would be best to leave it well alone. It had survived several centuries of oblivion and neglect; it would be a pity to see it destroyed now by good intentions.

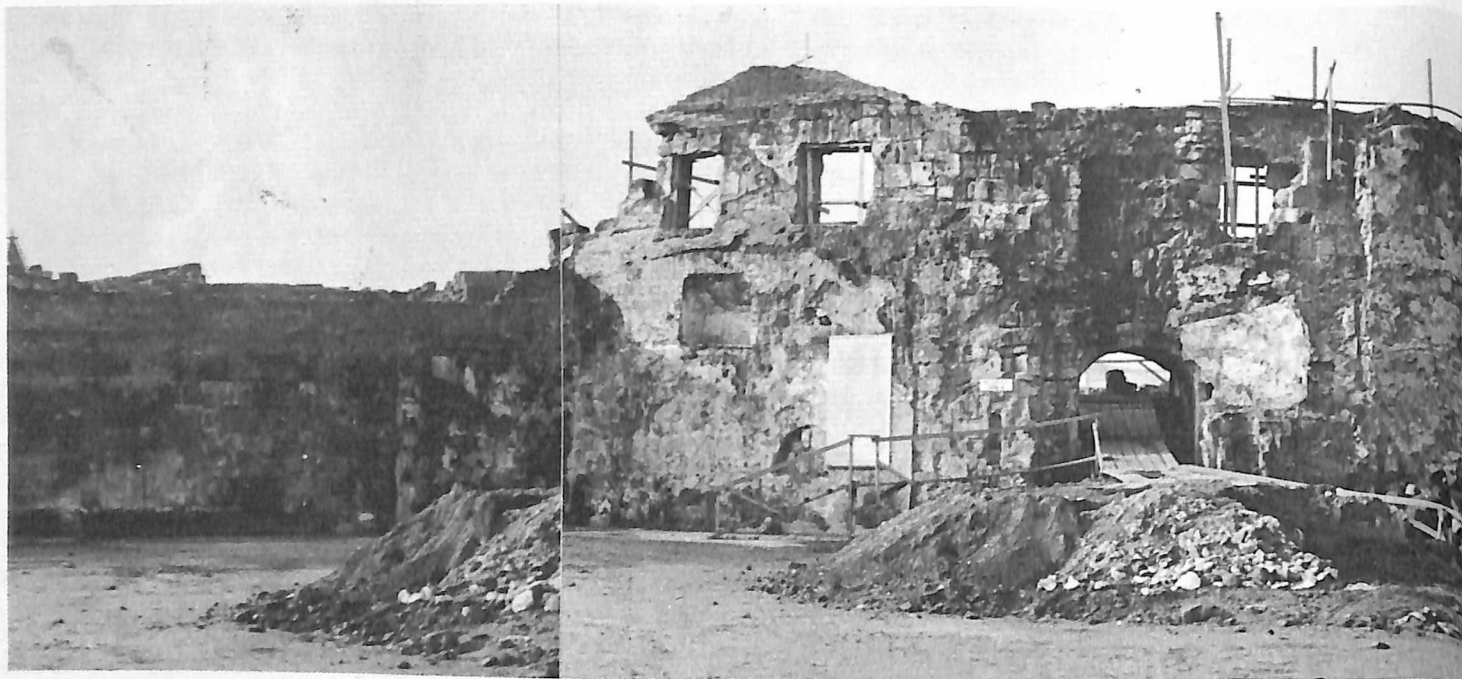
Photograph shows the condition of the west flank. The central portion of the drawing shows how mojonas—landmarks—were used to shore up eroding portion of the wall.

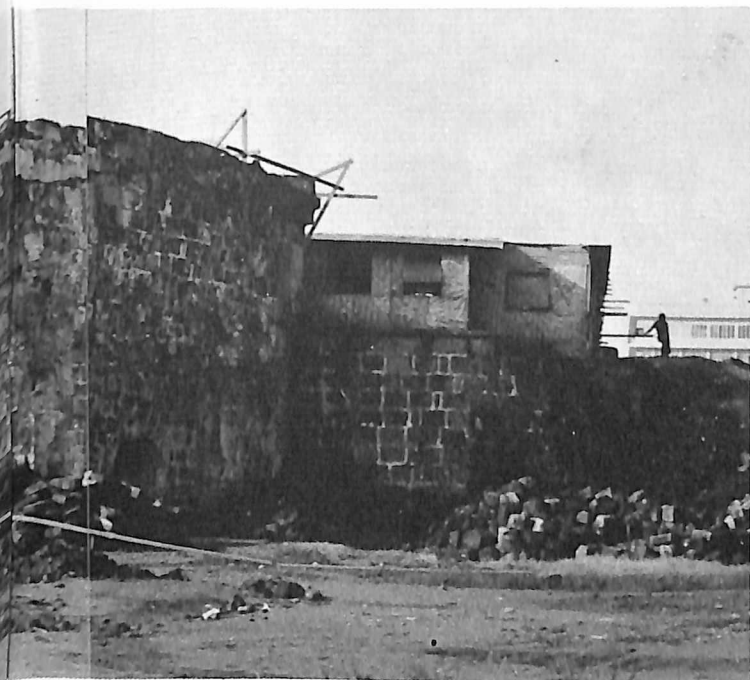
The façade of the Bastión de San Diego facing the Pamantasan ng Lungsod ng Maynila. The two casemates on the right side of the picture probably belong to the period of Vera and Sedeño or to the period of renovation instituted by Manrique de Lara. The eroded portion indicates the location of the ramp documented in the plans of Dionisio O'Kelly and Thomas Sanz, 1770 and 1779. The extreme left marks the location of the ramp, stair and wall documented in Sanz's plan of 1779. Though these projects are classified under obras executadas, there are no archaeological evidences of these structures.

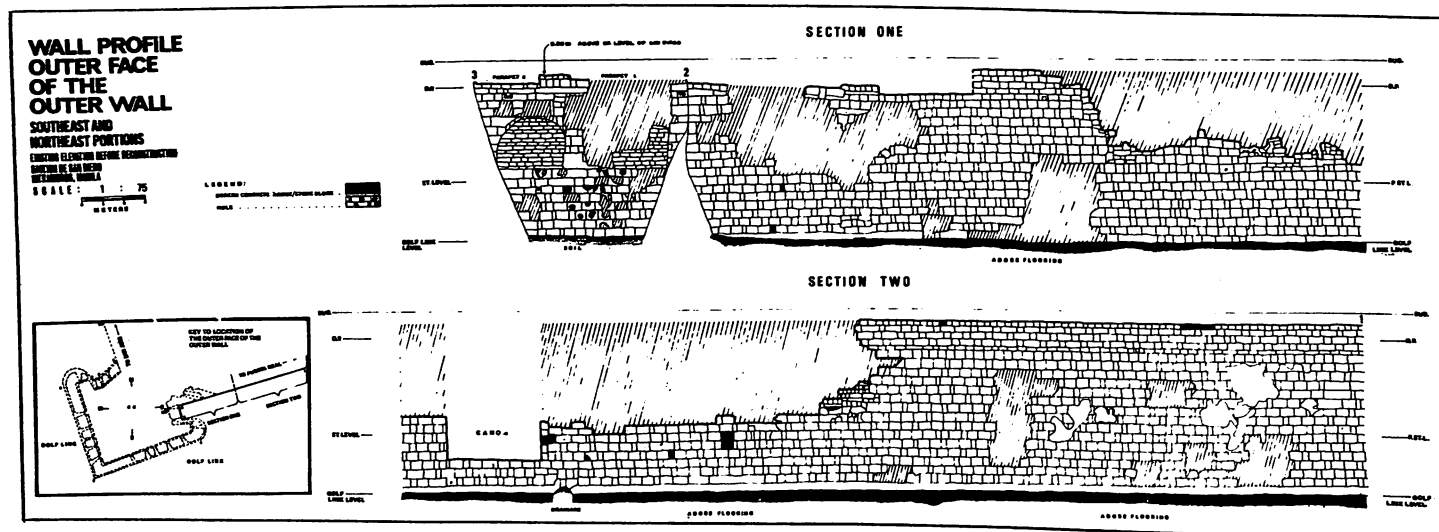
The status of the wall on the northeast portion and, below, the status and elevation of the wall on the southeast curtain wall.

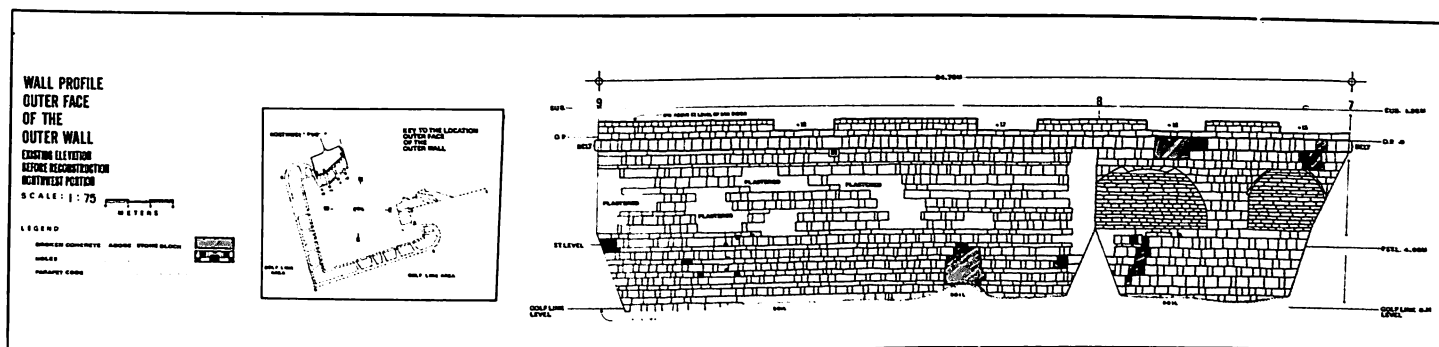
Existing elevation and status of the wall before reconstruction of the northwest portion.
